Manhole Inspection Summary

Manhole # S21I1_013MH

Insp Date: **4/13/08 2:30 PM**

Location Address: **2900 hollins ferry rd**

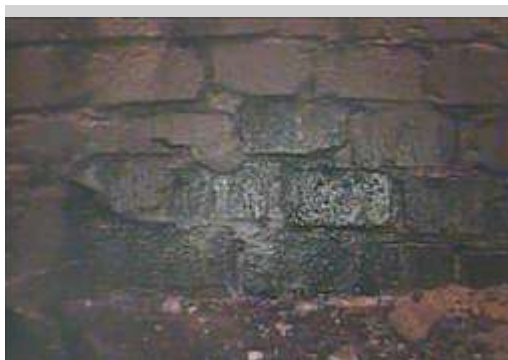
Defect 4

Infiltration: ☐ None ☐ Joint ☐ Cracks ☐ Mortar ☐ Roots ☒ **Wall**

infiltration @ barrel wall

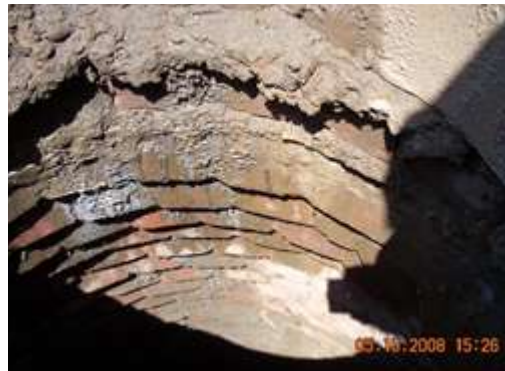
Defect 3

Infiltration: ☐ None ☒ **Joint** ☐ Cracks ☐ Mortar ☐ Roots ☐ Wall

infiltration @ chimney/frame joint

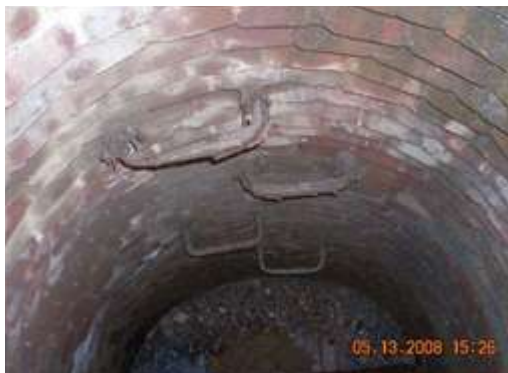
Defect 2

Steps Count: **4** Missing: **0** ☒ **Corroded**

corroded steps

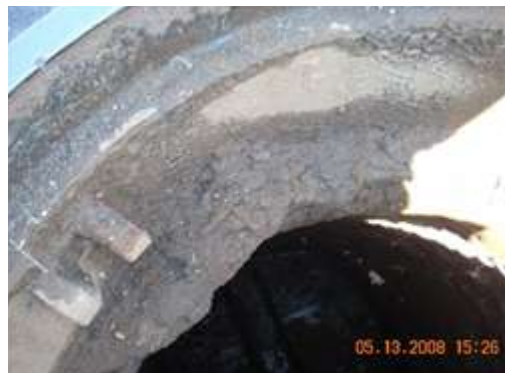
Defect 1

Frame Offset: **1** (in.) Condition: ☒ Sound ☐ Cracked ☐ Leaks

frame offset

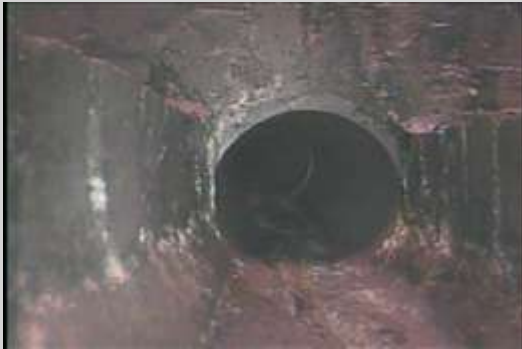
12 O'Clock Outflow

8 in. Circular Gravity Sewer
Pipe Out @ 12 O'Clock

Pipe Height: **8.4** (in.) Rod and Bar (Angled)
Pipe Material: **Clay** ☐ Pipe Lined
Invert Depth: **9.28** (ft.) Flow Characteristics: **Slow**
Deposits: ☒ None ☐ Mud ☐ Sludge ☐ Debris ☐ Grease
Silt Depth: **0** (in.) Deposits Extent:
Infiltration: **None** Pipe Seal Cond: **Sound**

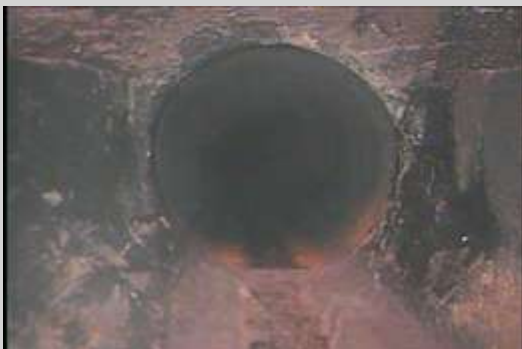
6 O'Clock Inflow

8 in. Circular Gravity Sewer
Pipe In @ 6 O'Clock

Pipe Height: **8.4** (in.) Rod and Bar (Angled)
Pipe Material: **Clay** ☐ Pipe Lined
Invert Depth: **8.98** (ft.) Flow Characteristics: **Slow**
Deposits: ☒ None ☐ Mud ☐ Sludge ☐ Debris ☐ Grease
Silt Depth: **0** (in.) Deposits Extent:
Infiltration: **None** Pipe Seal Cond: **Sound**
